PARKER RIVER BASIN
GEORGETOWN, MASSACHUSETTS

PENTUCKET POND OUTLET
MA 00261

PHASE I INSPECTION REPORT
NATIONAL DAM INSPECTION PROGRAM

OCTOBER 1979

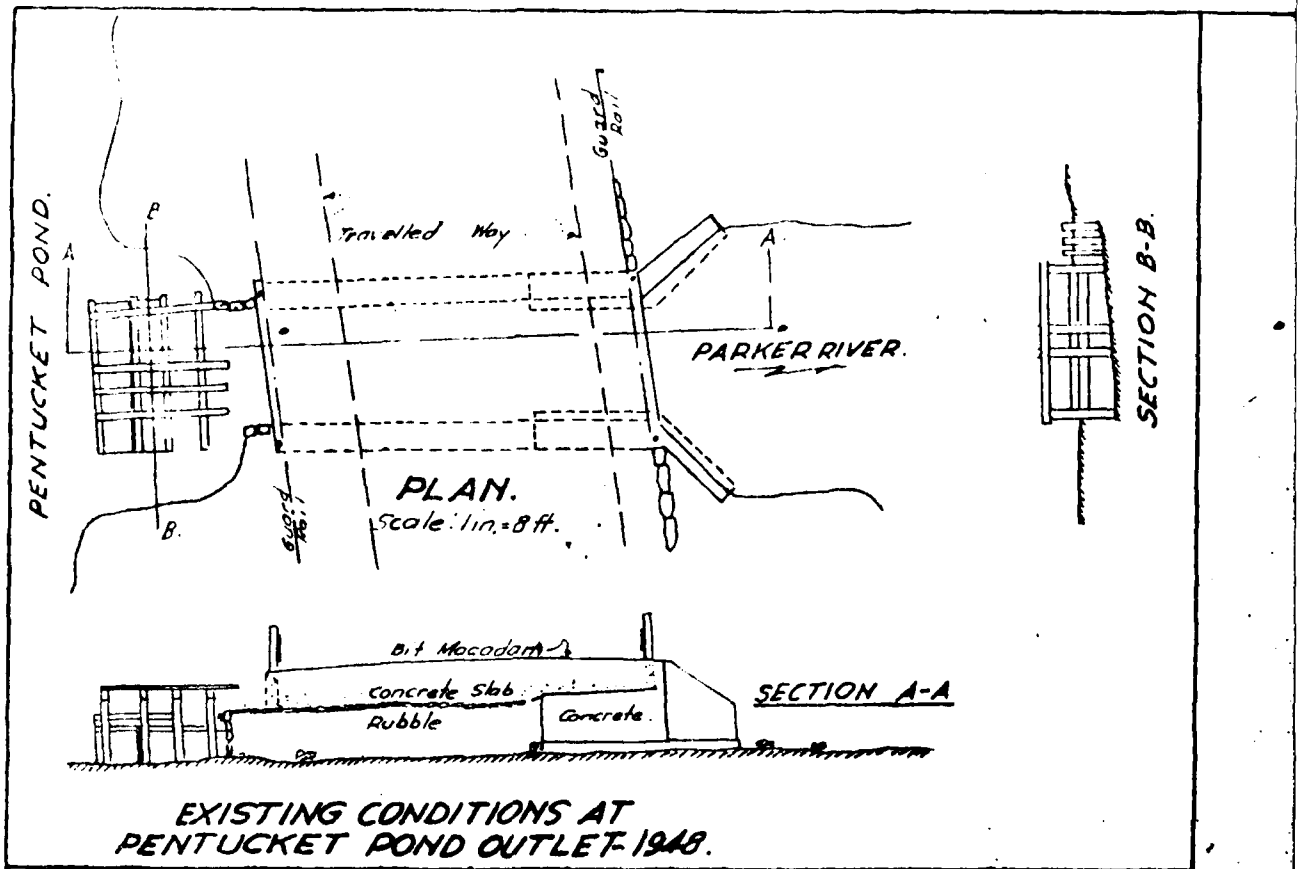
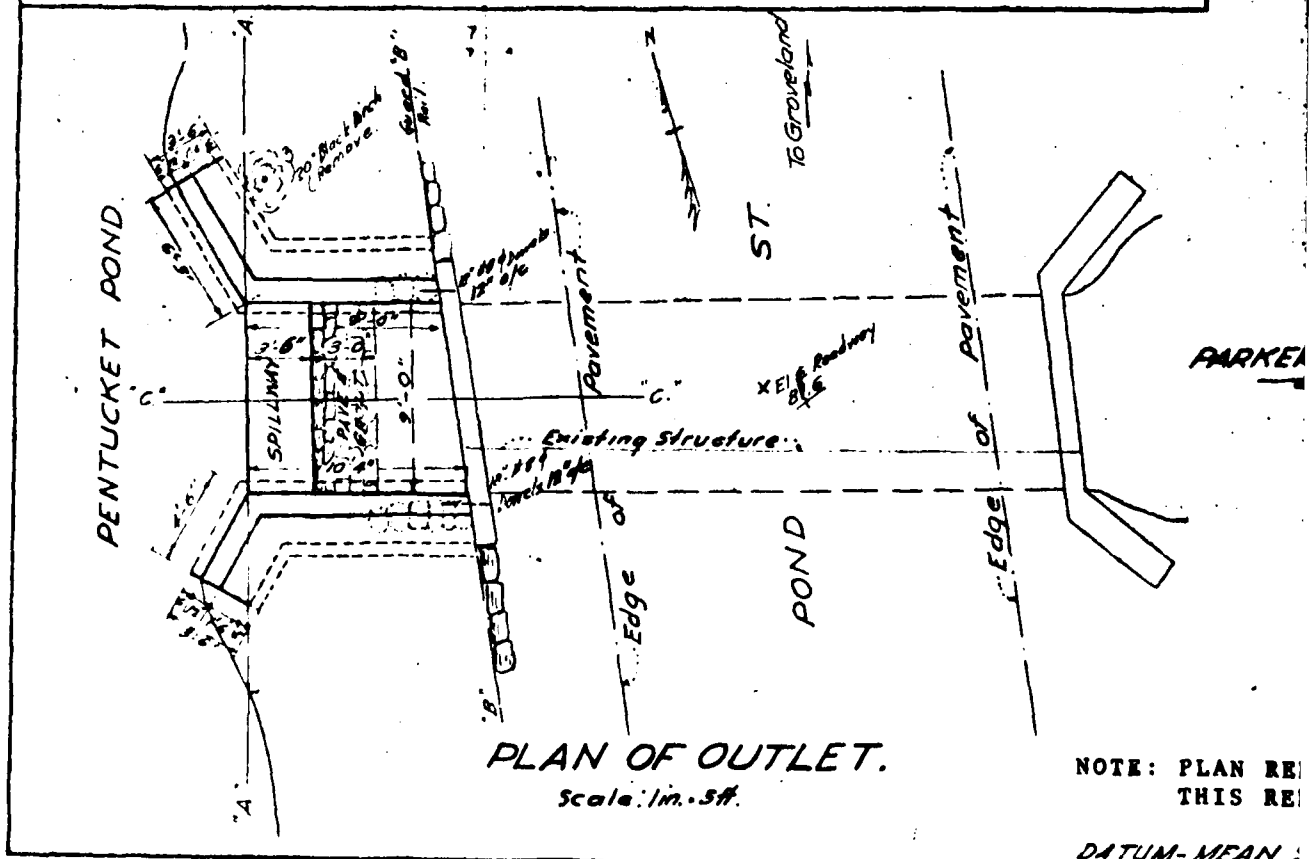
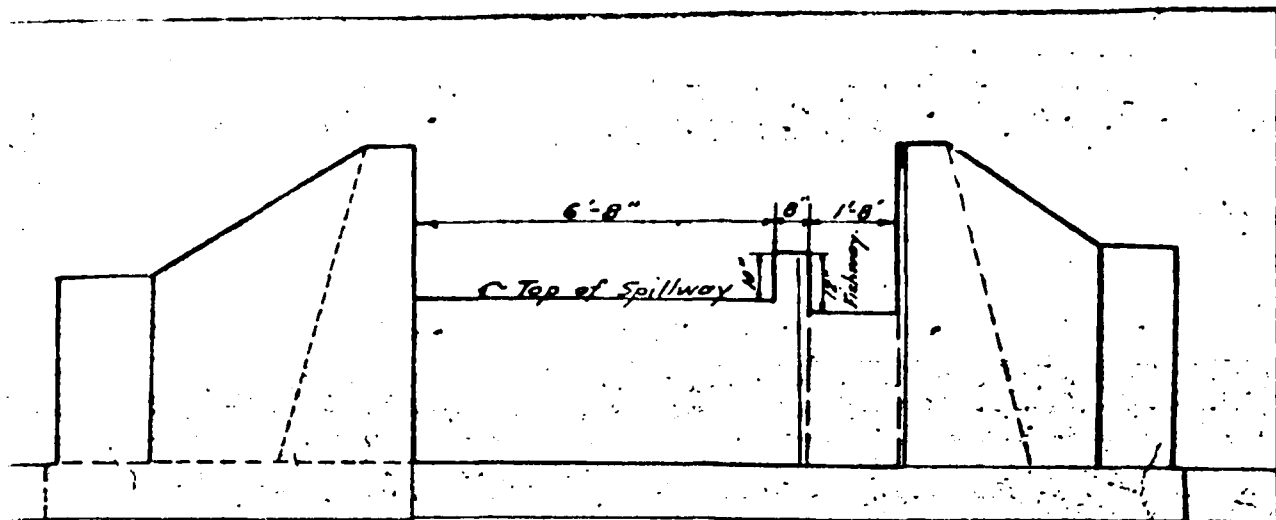
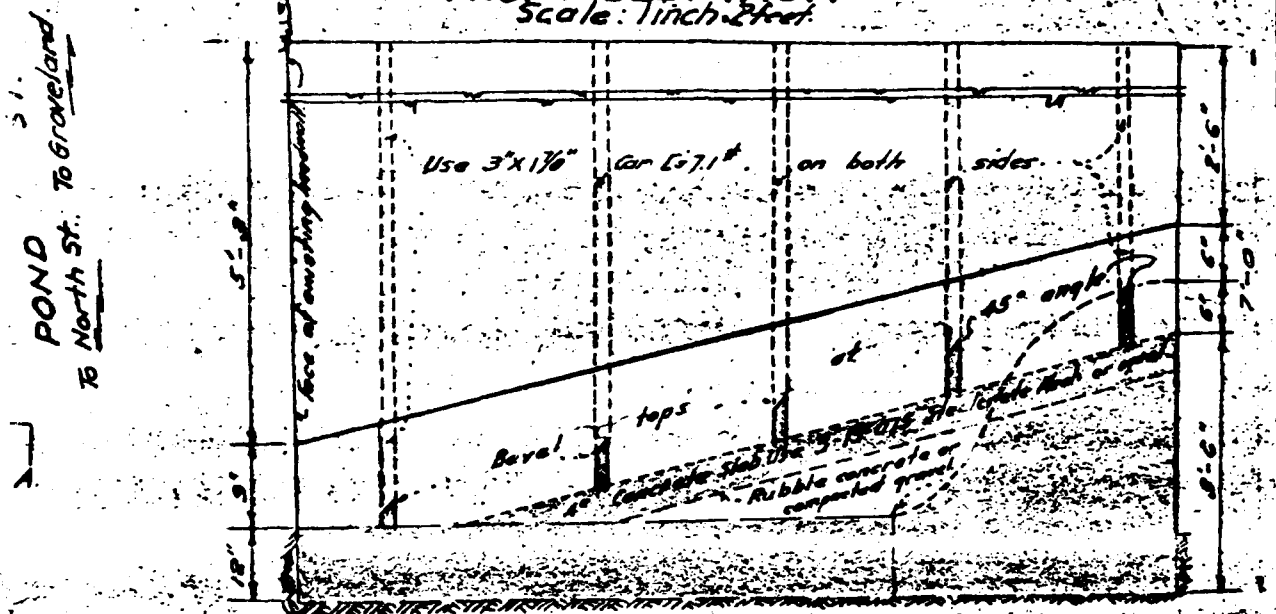
FIGURE B-4

Comparison of the drawings and the existing conditions indicate the fish ladder has been altered since the outlet has been rebuilt in 1965. Presently, the fish ladder is constructed of 2 x 6 and 1 x 4 timbers forming two pockets about one foot on center for the length of the fishway. The original design consisted of planks two feet on center (see Figure B-4).
